Unusual Fatigue Failure of Cobalt Chrome Alloy Cementless Femoral Stem: *Implant Retrieval and Biomechanical Analysis*

Received 2 Sep 2013; Accepted 16 Dec 2013; doi: 10.5405/jmbe.1681

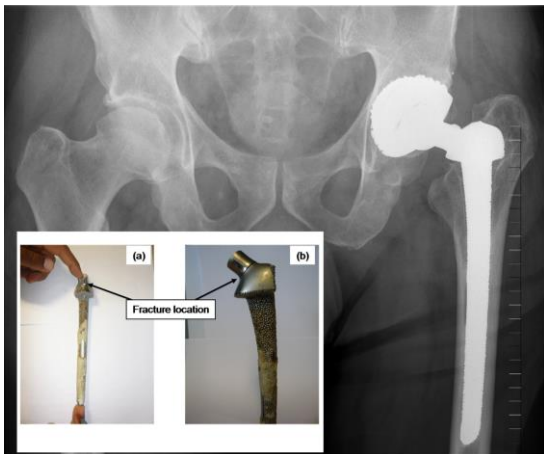
Figure 1. Anteroposterior radiograph showing prosthetic fracture at neck/stem transition. Insets (a) and (b) show the retrieved Lord femoral stem with a complete fracture at the neck/stem transition radius.

Implant failure occurred in the filler radius between stem and neck, as can be seen in insets (a) and (b) of Fig. 1. SEM images show that the crack initiated at the topside surface at the plastic deformation steps near machining feed marks due to slight stress concentrations. The arrow in Fig. 3(a) shows the crack initiation site. The crack then propagated primarily transgranularly, as can be seen in Fig. 3(a). A strong relief and

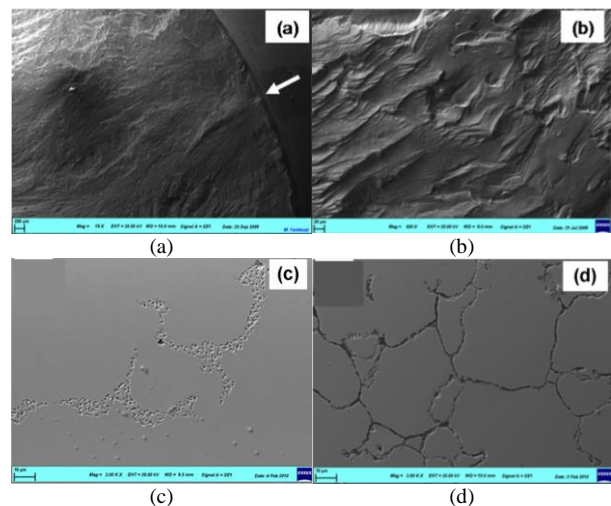
Figure 3. SEM fractography/micrography images showing: (a) the crack initiation site (arrow) at the implant surface and transgranular fracture surface; (b) a strong relief in the crack propagation phase; (c) precipitates along grain boundaries; and (d) the overall grain structure as seen in a cross-section of the broken implant.

plastic deformation features were seen across the fracture surface (Fig. 3(b)). The crack propagated through roughly half of the neck cross-section before final fracture occurred, which demonstrates the relatively high fracture toughness of the implant material. There was no evidence that inclusions or precipitates substantially promoted either crack initiation or crack propagation. The grain size, as shown in the SEM micrographs in Figs. 3(c) to 3(d), can be estimated to range between 6 and 70 μm , which falls within the range for the wrought CoCrMo alloy ASTM F1537 reported in the literature [2,3,7].

marks, and propagated primarily transgranularly. As such, no evidence exists that inclusions or precipitates substantially promoted crack initiation or crack propagation. The strong relief and plastic deformation features across the fracture surface (Fig. 3(b)) hint to three possible scenarios for the fracture progression. First, the implant may have been subjected to overload fatigue during the final state of its implantation life, which led to crack initiation, substantial plastic deformation ahead of the crack tip during crack propagation, and ultimately to implant failure. Particularly, the strong relief at the crack initiation site suggests that high loads such as those experienced during fall, jumping, or other extreme activities may have initiated the crack. Second, further compressive loading during subsequent patient activities after initial cracking may have further deformed the fracture surface. This is supported by the relatively long time span of six months between the detection of the initial crack preceding the first revision and the implant retrieval at the second revision. Third, the strong relief of the fracture surface may also result from partial intergranular crack propagation at some locations. This assumption is supported by the strong precipitation along grain boundaries (Fig. 3(c)), which can weaken grain boundaries and favor crack initiation and propagation along grain interfaces. However, although grain boundary carbides typical for the CoCrMo alloy ASTM F1537 may have contributed to accelerate the crack propagation, particularly in the final stage of implant failure, their contribution is estimated to be minor for the current investigated implant. This assumption is supported by the fact that the crack initiated at the surface and propagated primarily transgranularly. Microscopy investigations in the current study suggest that the crack was initiated at the tensile topside in the filler radius transitioning from the stem to the neck. This further highlights the hypothesis of overload fatigue as main failure cause, with the implant having good quality as compared to standard specifications and a new unused implant from the same manufacturer.
